**MONOTONIC AND FATIGUE LOADING
BEHAVIOR OF AN OXIDE/OXIDE
CERAMIC MATRIX COMPOSITE**

THESIS

Steven G. Steel, Captain, USAF

AFIT/GMS/ENY/00M-02

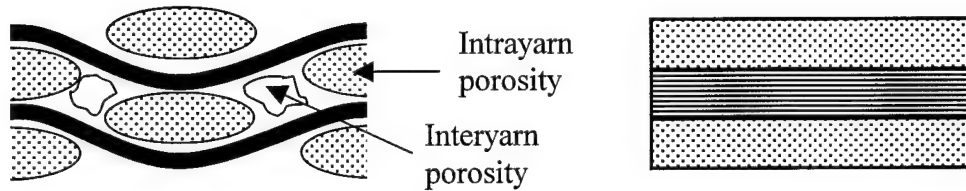
waviness of the fiber bundles. The two types of porosity present in a woven composite are illustrated in Figure 2-1. Microporosity ($\sim 10\mu\text{m}$) is present within individual tows, or yarns. Macroporosity ($>100\mu\text{m}$) is present between the yarns (16:222). This macroporosity can reduce composite strength and stiffness. Also, the significant bending of the fibers in woven composites can degrade their properties (8:16).

Figure 2-1 Cross section of woven (left) and cross-ply (right) laminates

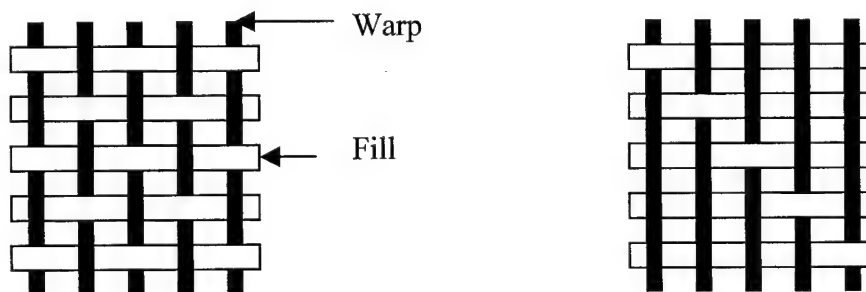
In a woven fabric, the lengthwise fibers are referred to as the warp yarns, while the transverse fibers are called fill yarns. Figure 2-2 shows the warp and fill directions in two types of weave: plain and satin (17:49).

Figure 2-2 Two types of weave: plain and satin

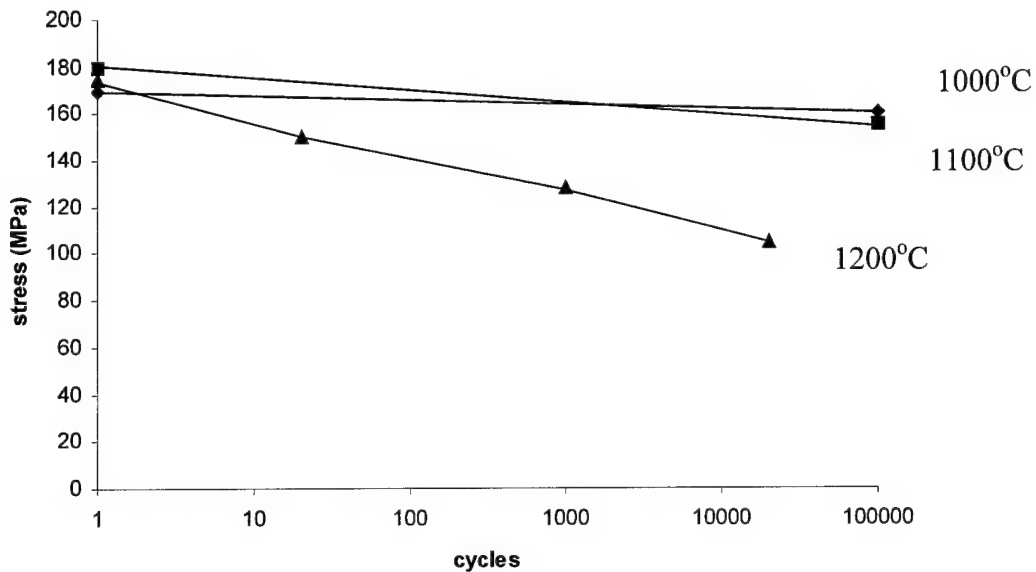
Figure 2-4 Fatigue behavior of Nextel 720/AS (from AFRL/MLLN)

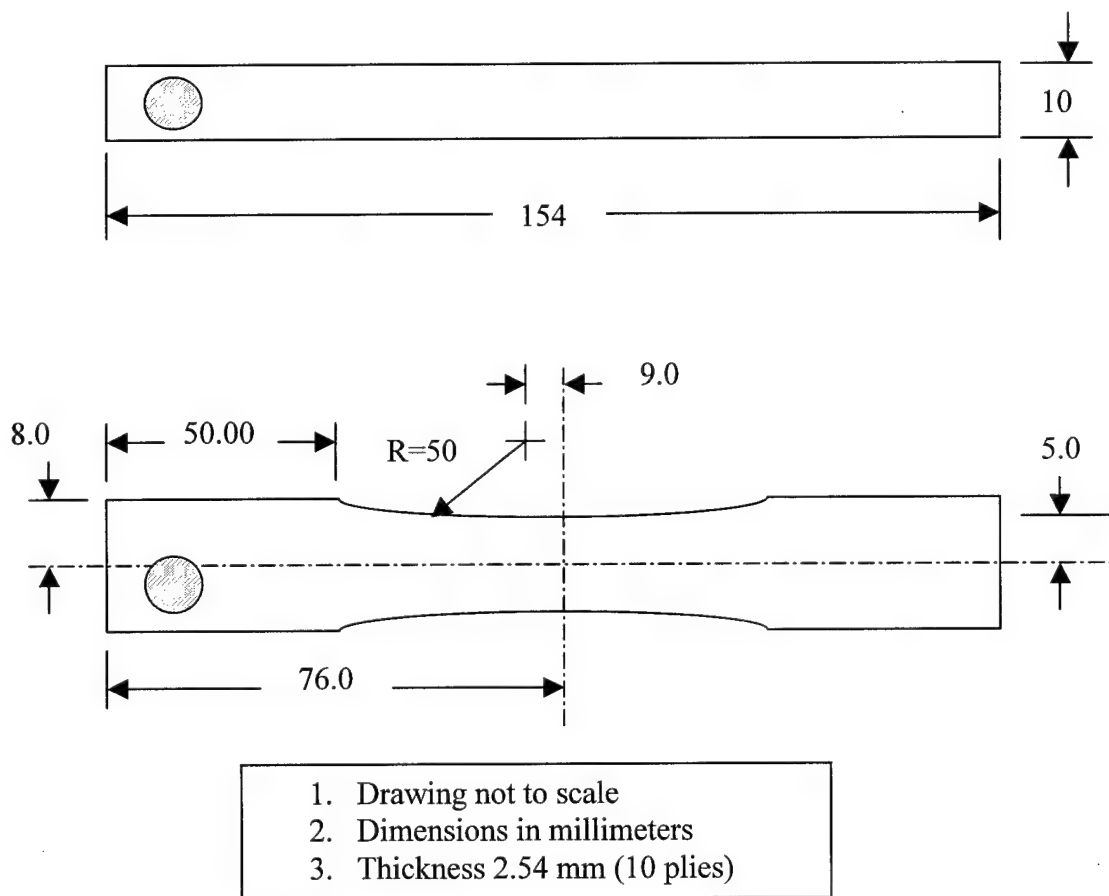
show the orientation of the fibers. The straight-sided specimens offer the advantage of low machining costs and no stress concentrations. They are generally used for monotonic tensile tests. The dog-bone specimens offer a reduced width gage length to encourage failure within the gage length region. This specimen geometry has a stress concentration factor of about 1.06 (39:37). This means if failure occurs in the transition region at a nominal stress of 140 MPa, the actual strength of the specimen is about 148 MPa. The dog-bone specimens are used for fatigue tests.

Figure 2-5 Straight-sided and dog-bone specimens (cutouts show fiber orientation)

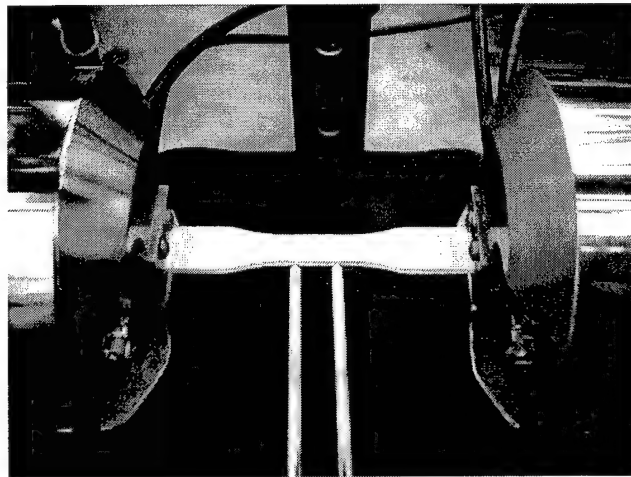
Load and extension data were acquired. Load was measured with an MTS 661.20E-01 load cell with a 25 kN capacity. The measured load was divided by specimen cross sectional area to get stress. Specimen extension was measured with an MTS extensometer model number 632.53E-14. The extensometer used two alumina rods, spaced 12.7 mm (0.5 inches) apart, held against the specimen with spring pressure as shown in Figure 3-1.

Figure 3-1 Specimen in grips with extensometer rods

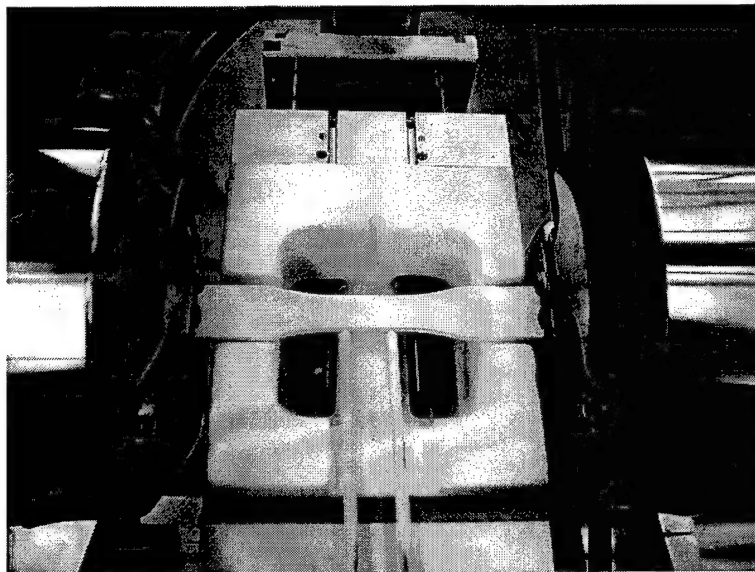
1200°C testing was accomplished using a two zone Amteco Hot-Rail Furnace System. The chamber of the furnace is compact, about 5x5x8 cm, so the heat is applied to a very localized area. Figure 3-2 shows the bottom half of the furnace in place beneath the specimen. The furnace chamber has two zones with two silicon carbide heating elements per zone.

Figure 3-2 Furnace set-up (Bottom half)

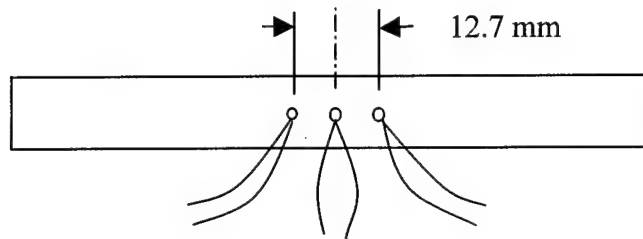
To ensure a specimen temperature of 1200°C the following procedure was used. Three S-type thermocouples were bonded to a dummy specimen in the location shown below.

Figure 3-3 Thermocouple layout on dummy specimen

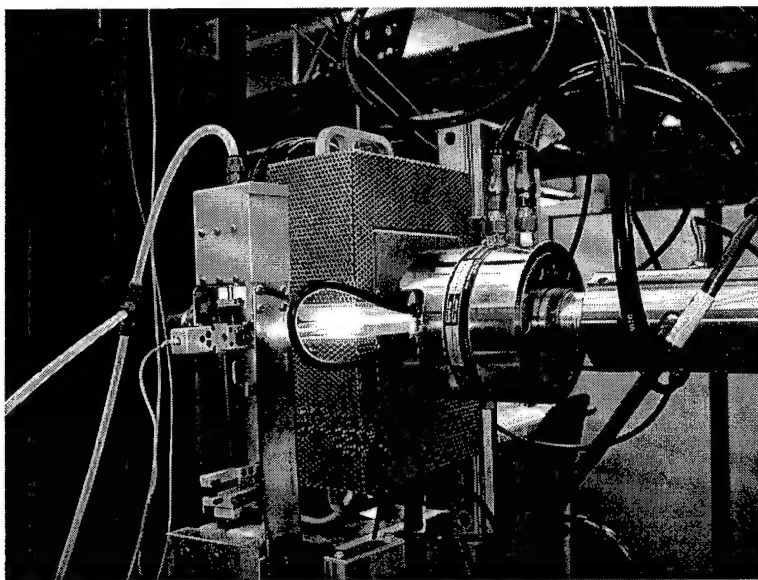
The furnace was started and the specimen temperature ramped to 1200°C using the Barber Colemans' automatic control. It took approximately 25 minutes to go from room temperature to 1200°C. There was an overshoot in temperature of about 18°C (the temperature peaked at 1218°C then settled at 1200°C). Once at 1200°C the specimen temperature remained essentially constant. The center thermocouple read 1203°C and the two outer ones 1198°C. In order to get this specimen temperature, the two Barber Coleman controllers had to be set at 1080°C and 1093°C. This difference between the furnace thermocouples and the specimen thermocouples (of over 100°C) indicates a fairly steep temperature gradient within the furnace.

Figure 3-4 High temperature test in progress

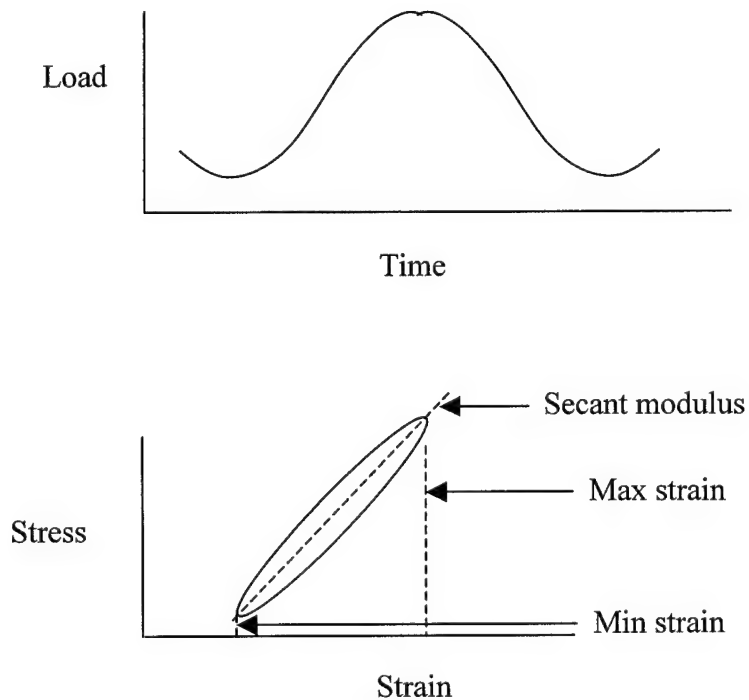
Cyclic tension tests were done at room temperature and 1200°C. The tests were done in load control with a load ratio of 0.05 ($R = \sigma_{\max}/\sigma_{\min}$). The applied load had a sine wave form as shown in Figure 3-5 and a frequency of one hertz (one cycle per second).

Figure 3-5 Applied fatigue load and associated stress-strain loop

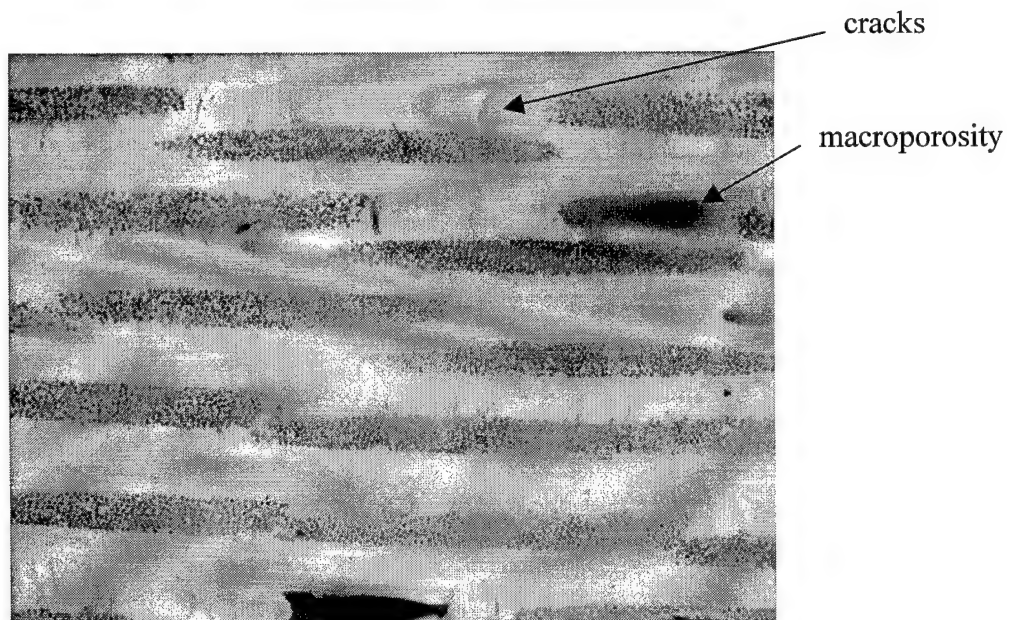
Before tests, initial investigation was done with the optical microscope to characterize the microstructure of the oxide/oxide, N720/A, in the as-received condition. Figure 4-1 shows a 'through the thickness' view showing the major components of the composite. The 90° fiber tows of the 8HSW are visible as well as the macroporosity and cracks between the tows.

Figure 4-1 Microstructure of N720/A, 50X

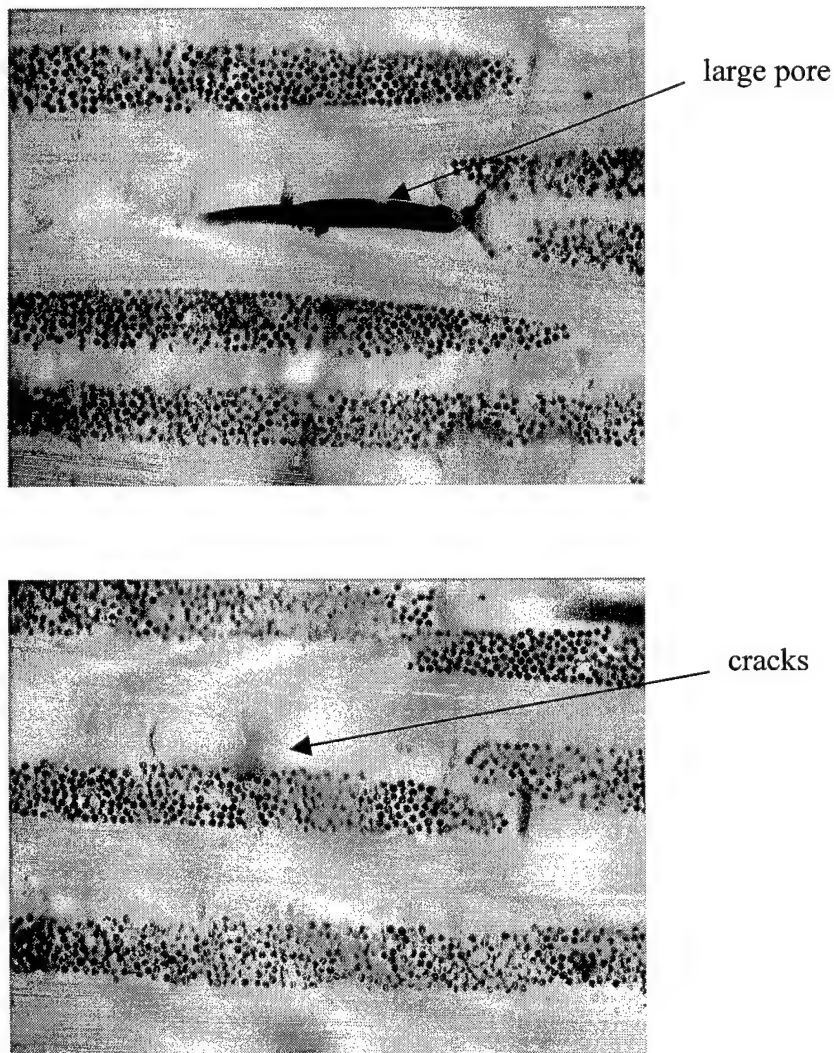
Figure 4-2 shows two views of the microstructure at a higher magnification to give a better view of the cracks and pores between the fiber tows. The cracks are due to matrix shrinkage that occurs during the sol-gel processing, as the liquid ceramic precursor solidifies. The large pores are due to the woven fiber architecture. The ceramic precursor has difficulty infiltrating the regions in between the woven fiber tows.

Figure 4-2 Microstructure of N720/A, 100X

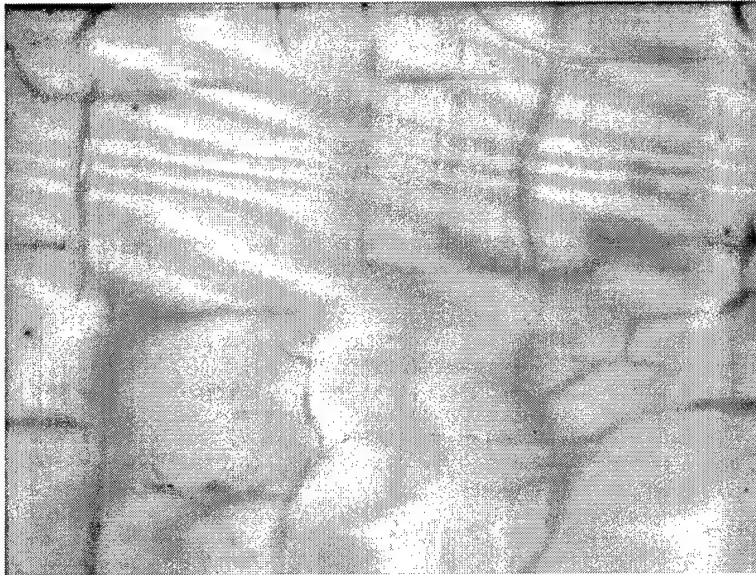
Figure 4-3 shows the cracked condition of the matrix on the surface of the specimen. The cracks are again due to the shrinkage that occurs during the sol-gel processing.

Figure 4-3 Matrix cracks on specimen surface, 100X

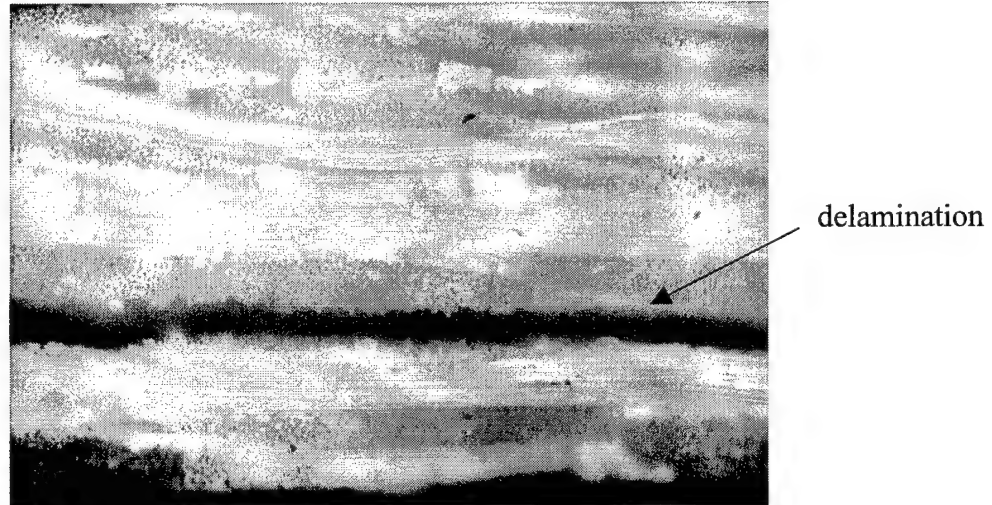
Figure 4-4 shows a delamination, or separation of plies, present at the grip section of a specimen. Such delaminations were present on several specimens. In general, the quality of the composite suffered near the edges of specimens.

Figure 4-4 Delamination of plies in grip region, 50X

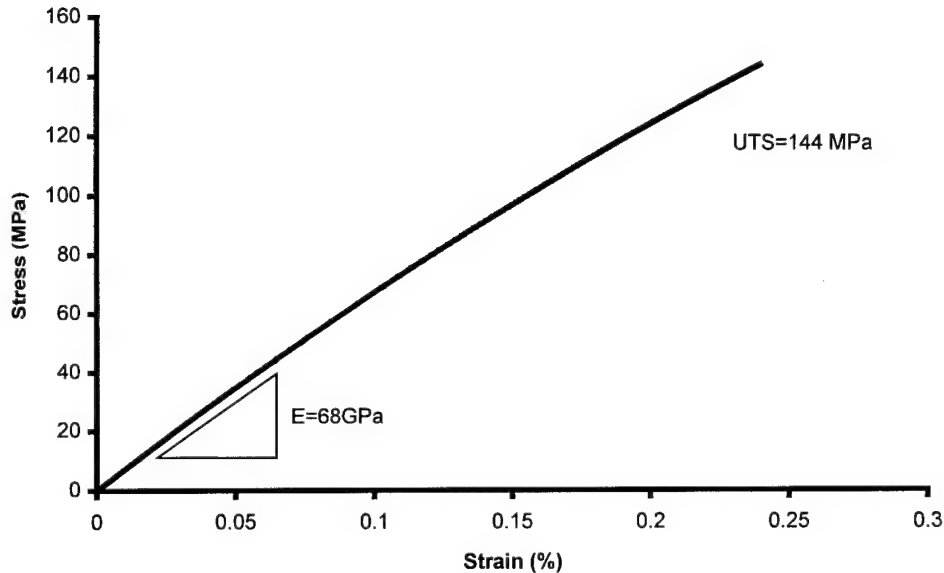
Figure 4-5 shows the stress-strain curve for specimen 2. It is typical of the three monotonic tests. A second-degree polynomial curve fit the data very nicely. The stress-strain response is nearly linear at first and then becomes slightly non-linear.

Figure 4-5 Typical room temperature stress-strain curve for N720/A

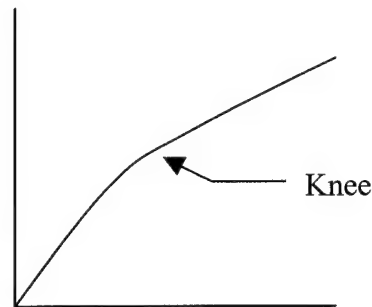
matrix is saturated with cracks the stress strain response becomes linear again and most of the load is carried by 0° fibers.

Figure 4-6 Typical stress-strain response of CMC showing proportional limit

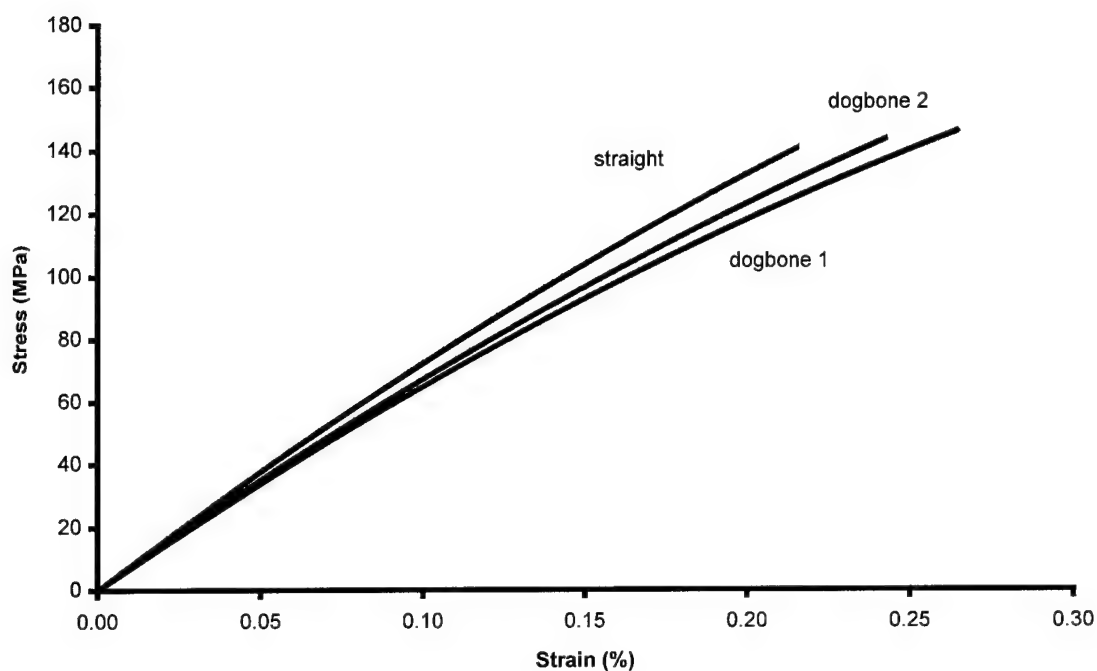
All three monotonic tests are plotted on the same graph in Figure 4-7.

Figure 4-7 Comparison of three room temperature stress-strain curves

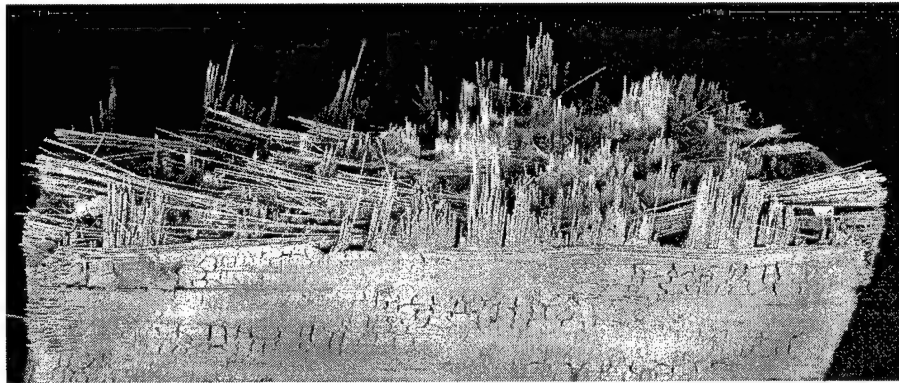
The following series of SEM photographs show the fracture surface of a tensile specimen at increasing levels of magnification. Figure 4-8 shows the entire fracture surface at a magnification of 20X. The fracture plane is fibrous and rough with fiber tows breaking

Figure 4-8 Fracture surface of room temperature tensile specimen, 20X

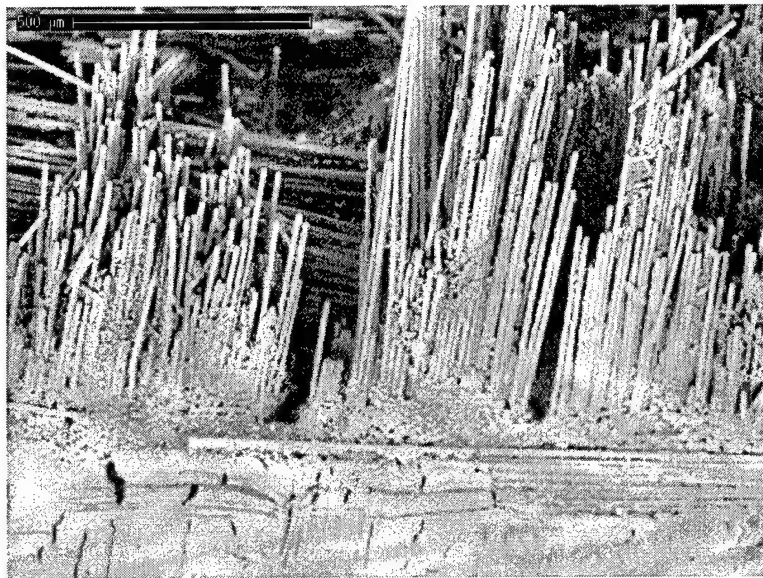
Figure 4-9 shows the surface at a magnification of 50X. Several zero degree fiber tows are visible in this photograph. Individual fibers within each tow are also broken over a range of axial locations. This indicates the porous matrix is not only effective at crack deflection in between the tows but also between individual fibers within the tows.

Figure 4-9 Fracture surface of room temperature tensile specimen, 50X

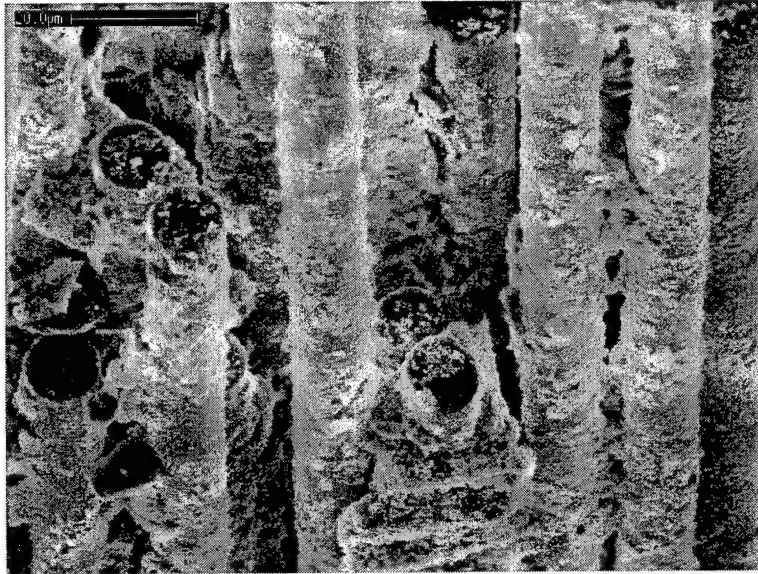
Figure 4-10 shows apparent fiber pullout on the fracture surface at a magnification of 1000X, but this is different than the fiber pullout mechanism of traditional CFCCs. No

Figure 4-10 Fracture surface of room temperature tensile specimen, 1000X

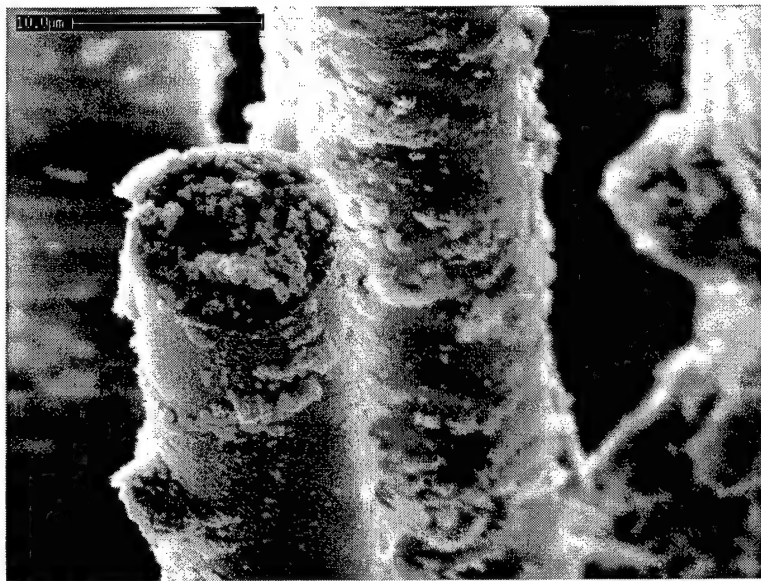
fibers appear smooth. Because of the weak fiber coating, they debond and pull out of the matrix material cleanly without the attached matrix material.

Figure 4-11 Fracture surface of room temperature tensile specimen, 3000X

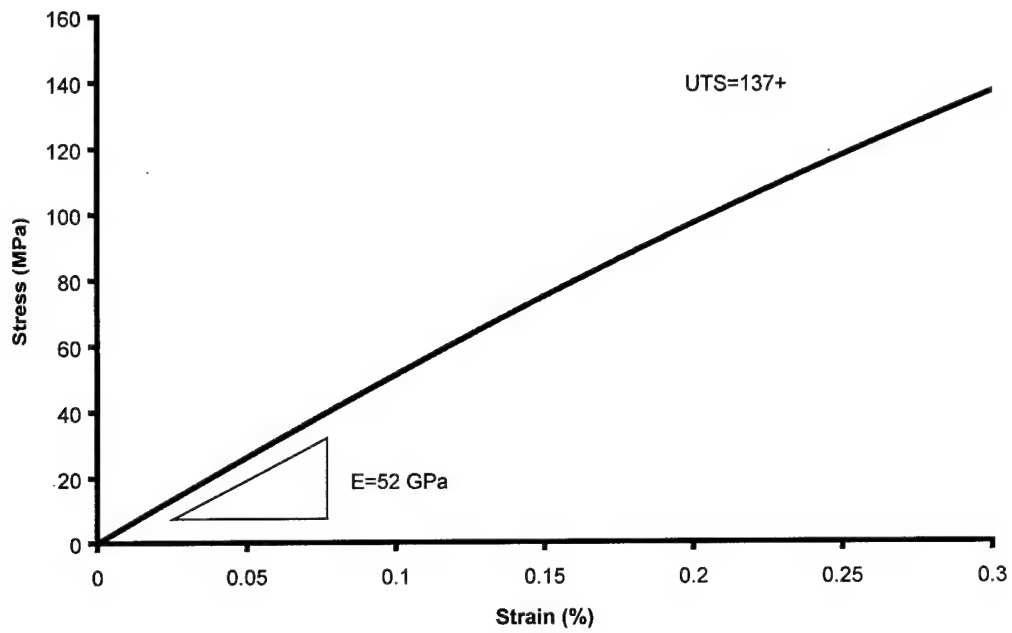
Overall, this material has very good monotonic tensile properties at 1200°C. Figure 4-12 shows a typical stress-strain curve obtained at 1200°C (specimen #5). It has the same characteristics as the room temperature tests, linear at low stress and then slightly non-linear at higher stress as the matrix cracks. Figure 4-13 shows a comparison of stress-strain curves at the two different temperatures. The difference in modulus and strain to failure is evident.

Figure 4-12 Typical stress-strain behavior at high temperature

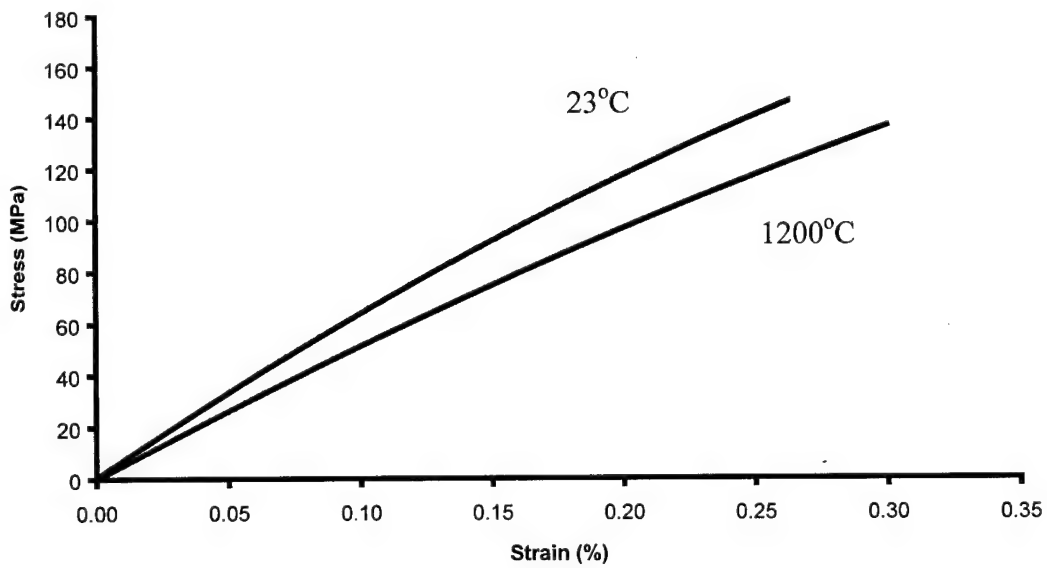
Figure 4-13 Comparison of tensile response at two temperatures

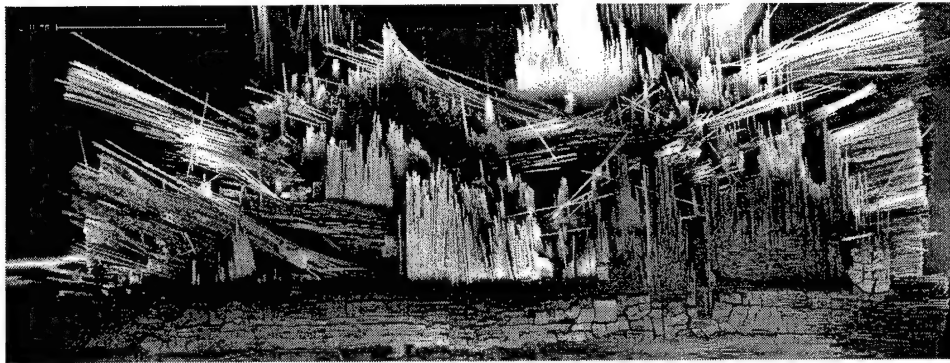
Figure 4-14 is an SEM image of the fracture surface of a high temperature monotonic specimen at a magnification of 20X.

Figure 4-14 Fracture surface of 1200°C monotonic specimen, 20X

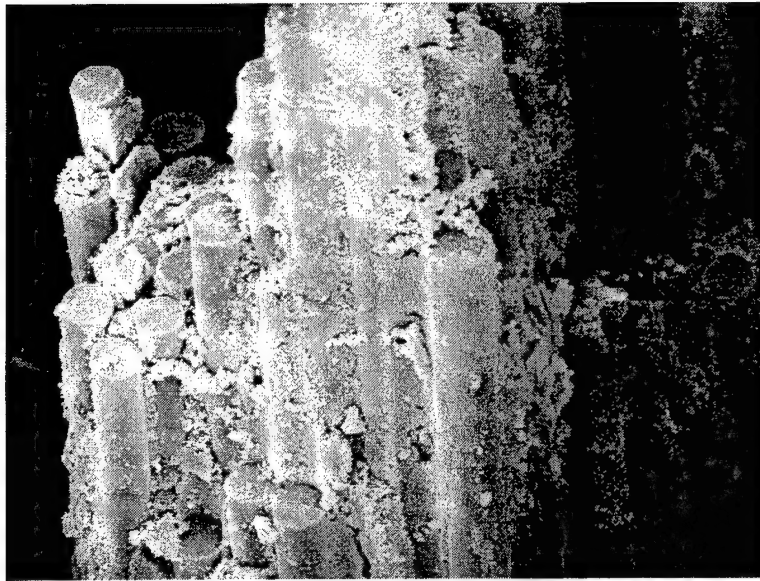
**Figure 4-15 Fracture surface of 1200°C monotonic specimen,
700X**

Figure 4-17 shows how the matrix has sintered to the fibers and consequently the crack travels directly from the matrix through the fiber with no deflection. This is in contrast with the irregular fracture surface shown in Figure 4-15.

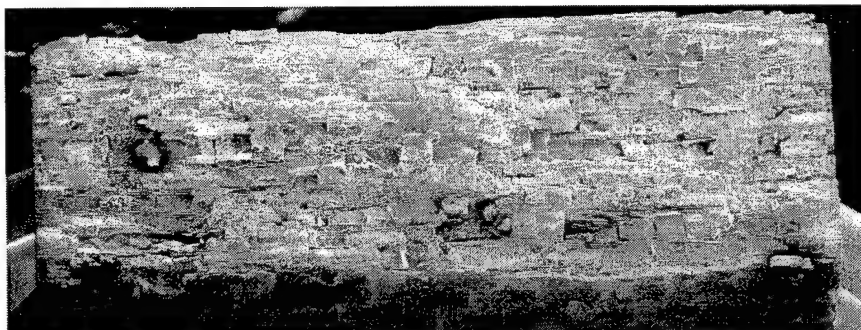
this role it was subjected to temperatures of 1200°C for several hours total. It was then accidentally dropped on the floor and it suffered a brittle fracture. The following figures illustrate the improvement in high temperature performance of N720/Alumina over GEN IV (N610/Aluminosilicate).

Figure 4-16 Fracture surface of GEN IV after 1200°C exposure, 20X

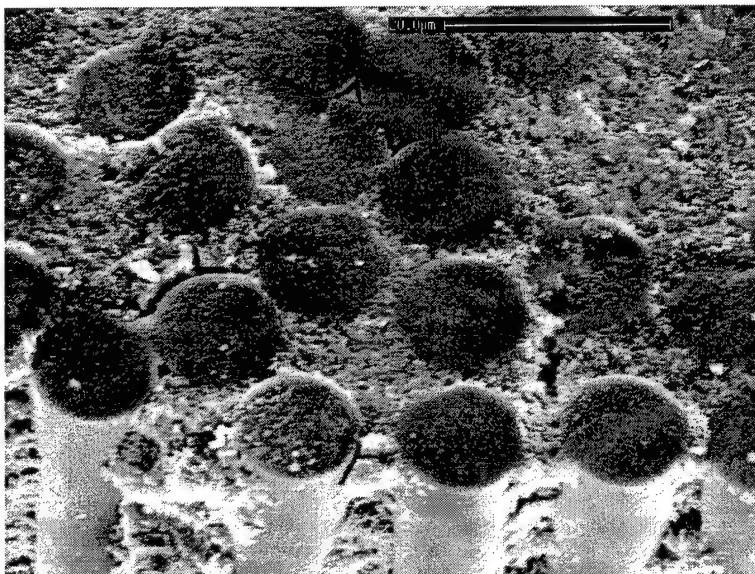
Figure 4-17 Fracture surface of GEN IV, 1800X

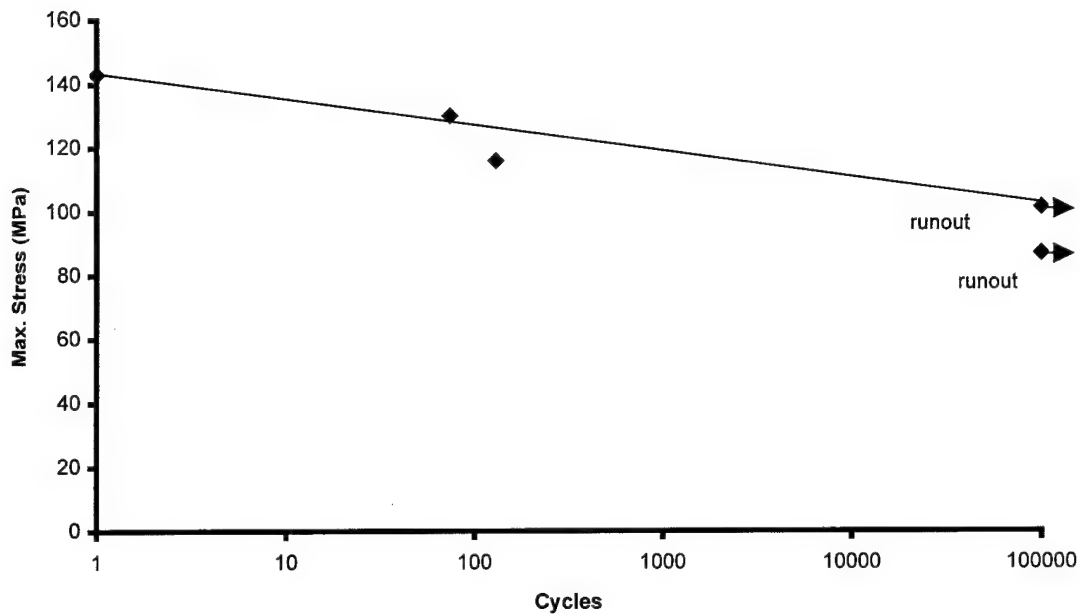
it is nearly horizontal. Specimens tested at 90 and 80% stress levels failed after only 70 and 130 cycles.

Figure 4-18 Room temperature S-N curve for N720/A

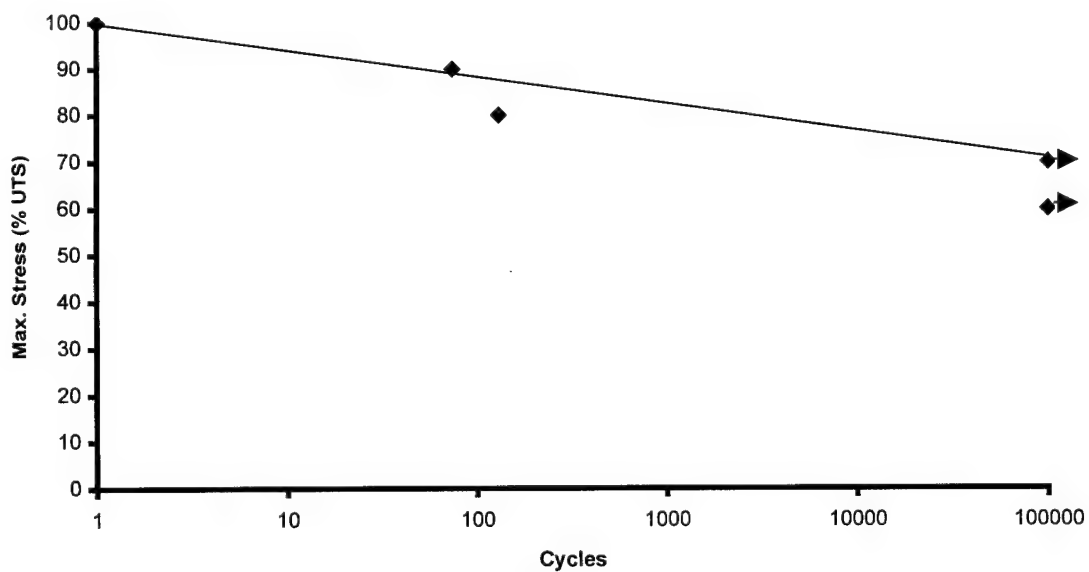
Figure 4-19 Normalized room temperature S-N curve for N720/A

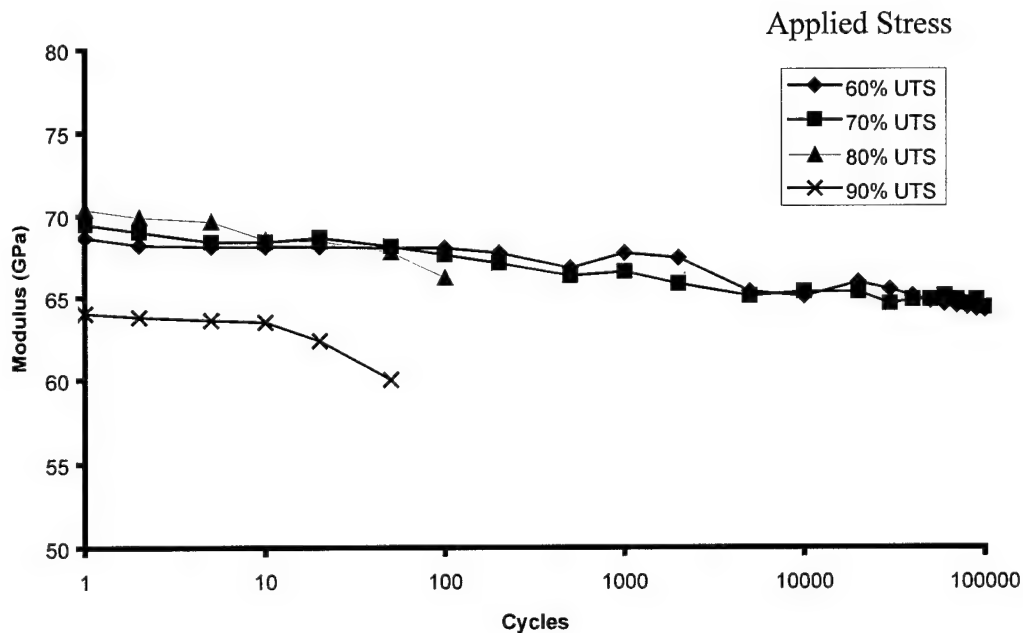
Figure 4-20 shows the modulus behavior for the four room temperature fatigue tests. For convenience the modulus used here is the secant modulus. Because the stress-strain behavior is close to linear, there is very little difference between the secant modulus and the tangent modulus calculated in the monotonic tests. As Figure 4-20 shows, there is a definite decreasing trend in the modulus behavior with cycling.

Figure 4-20 Modulus degradation during room temperature fatigue

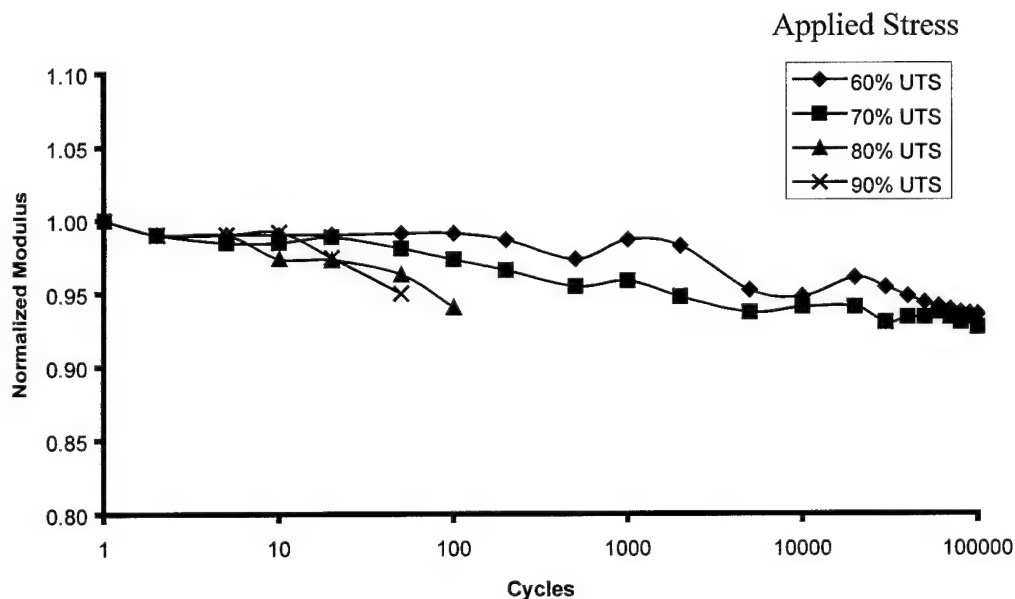
Figure 4-21 shows the same data but with normalized moduli. Here moduli are normalized by dividing by the initial modulus measured in the first stress cycle. This figure shows the same trend as Figure 4-20. However it also shows that even after 100,000 cycles in the 60 and 70% tests the modulus maintains 92-93% of its initial value. So the degradation in composite stiffness is relatively small. This slight degradation is likely due to additional matrix cracking, beyond the initial cracked condition. Another possible explanation for the decreasing modulus is that the fraction of broken fibers may increase with the number of cycles, especially at the higher stress levels. The data also appears to show that the higher the stress level the more the modulus degrades.

Figure 4-21 Trends in normalized modulus during room temperature fatigue

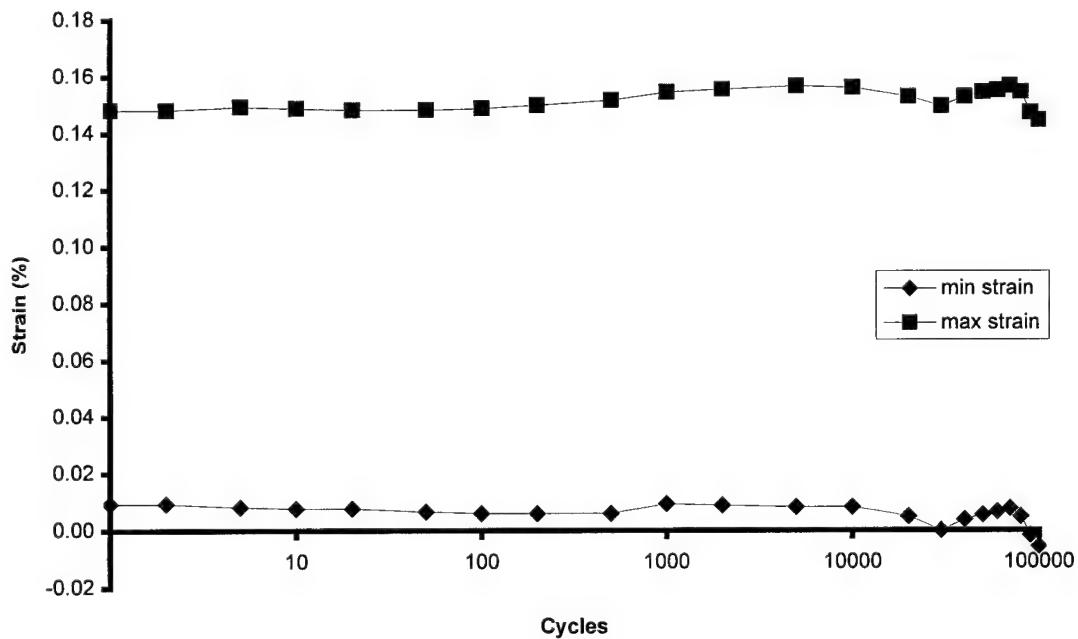
60% test. The data shows that there is very little strain accumulation during the course of the fatigue tests. The maximum strain increases slightly due to the decreasing modulus. If both the maximum and minimum strain increase over the course of a test, this would indicate permanent strain accumulation by mechanisms such as interfacial wear (strain ratcheting). But this is not the case here. There is little or no debonding and sliding between the fibers and matrix. The apparent strain decrease over the last 30,000 cycles in Figure 4-22 is most likely due to a slipping extensometer.

Figure 4-22 Strain progression in 70% stress level, room temperature fatigue test

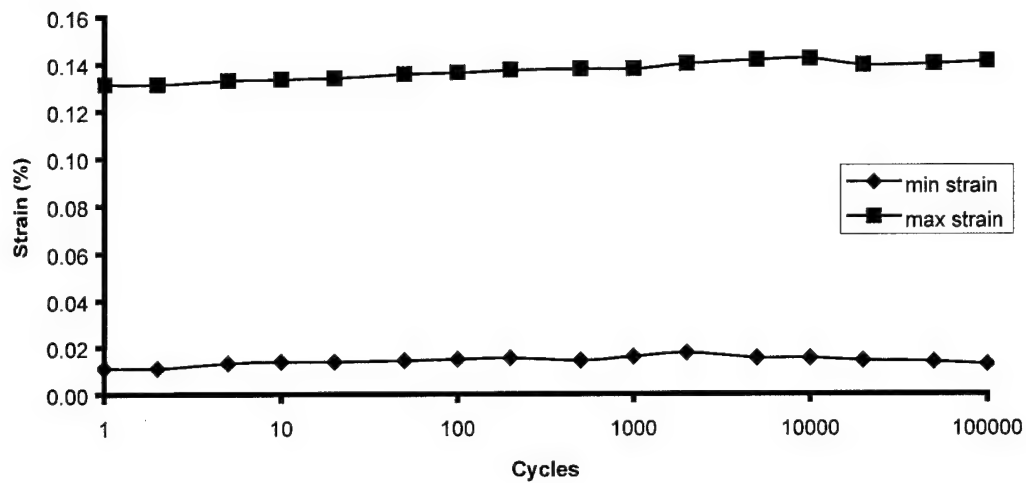
Figure 4-23 Strain progression in 60% stress level, room temperature fatigue test

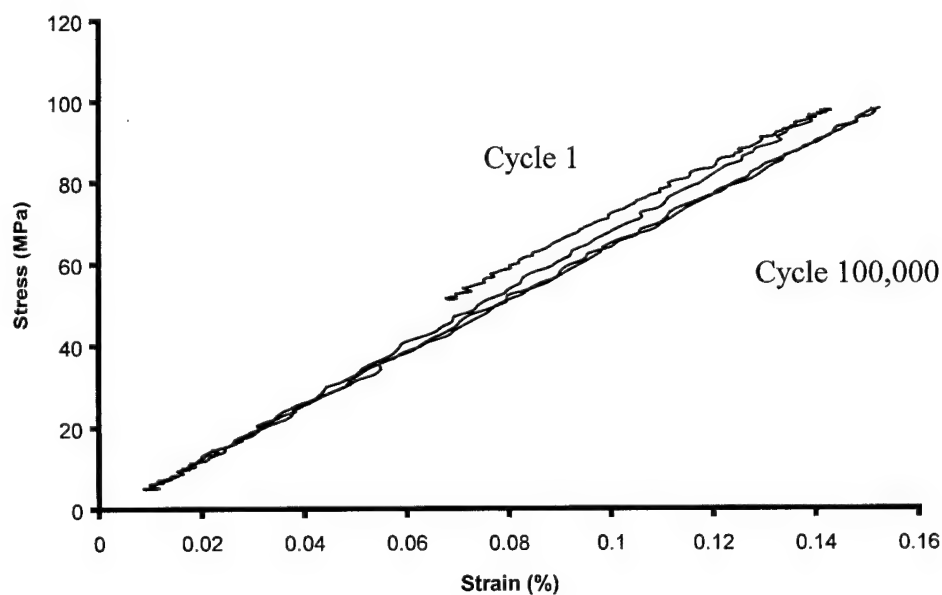
Stress-strain loop plots are a third way to track damage occurring during fatigue. Figure 4-24 shows stress-strain loops for the first and last cycles of the 70% stress level test.

Figure 4-24 Changes in stress-strain loops during room temperature fatigue (70%)

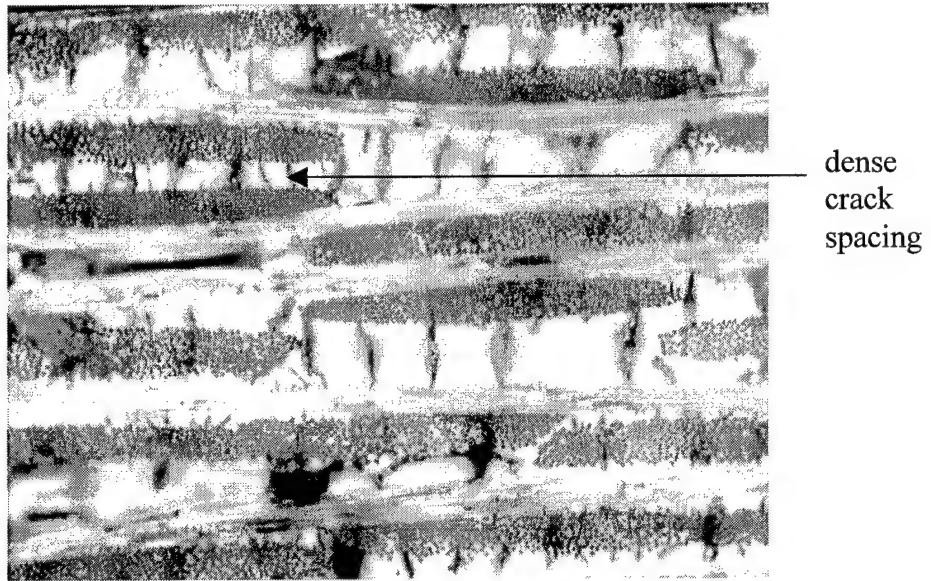
Figure 4-25 Possible fatigue damage, 50X

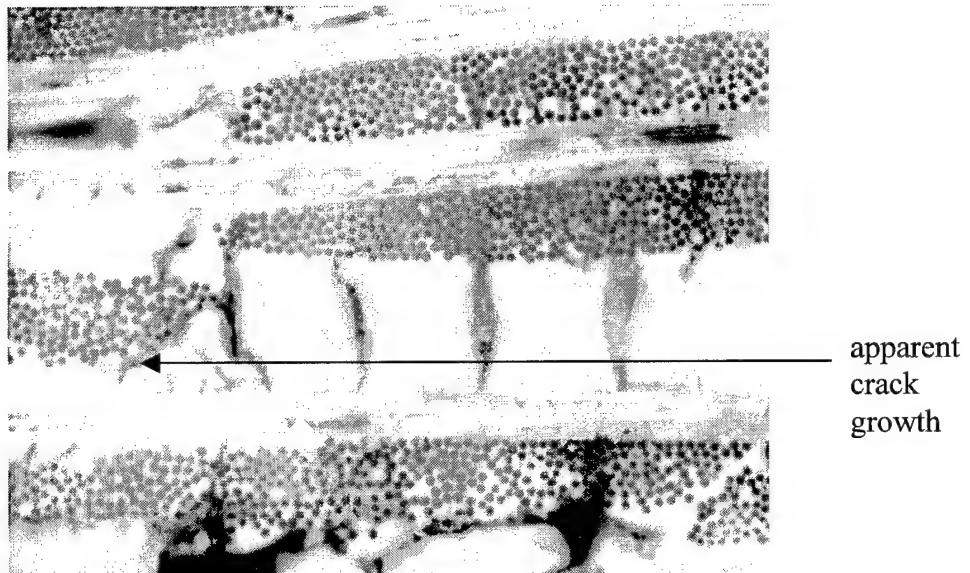
Figure 4-26 Possible fatigue damage, 100x

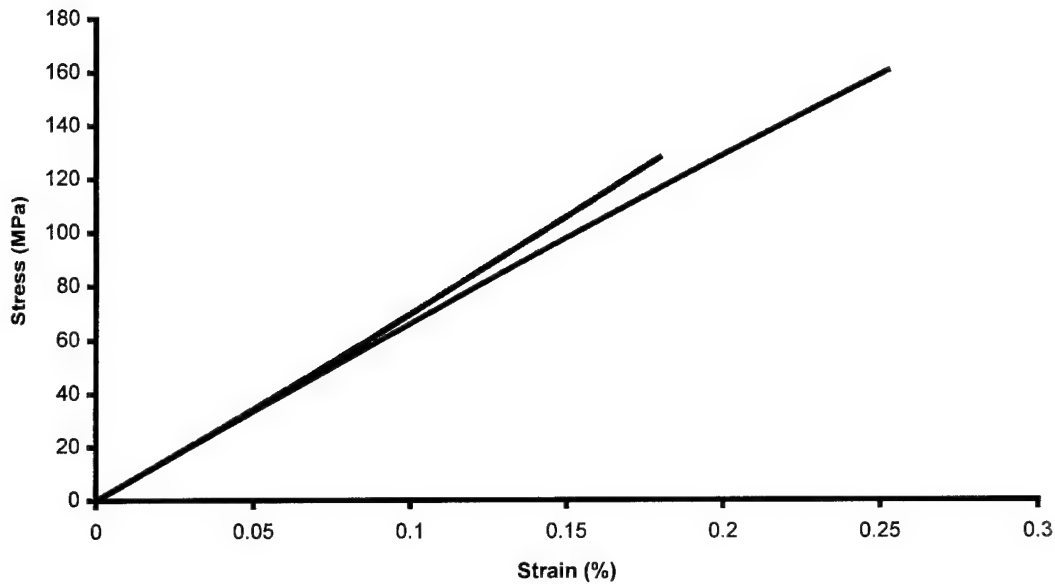
The fourth way to study fatigue damage is to test the strength of specimens that survived 100,000 fatigue cycles. If any damage occurred during fatigue, the retained strength of these specimens will be lower than the strength of specimens not subjected to fatigue. The results from the retained strength tests are plotted in Figure 4-27 and summarized in Table 4-7.

Figure 4-27 Stress-strain curves of room temperature fatigue runout specimens

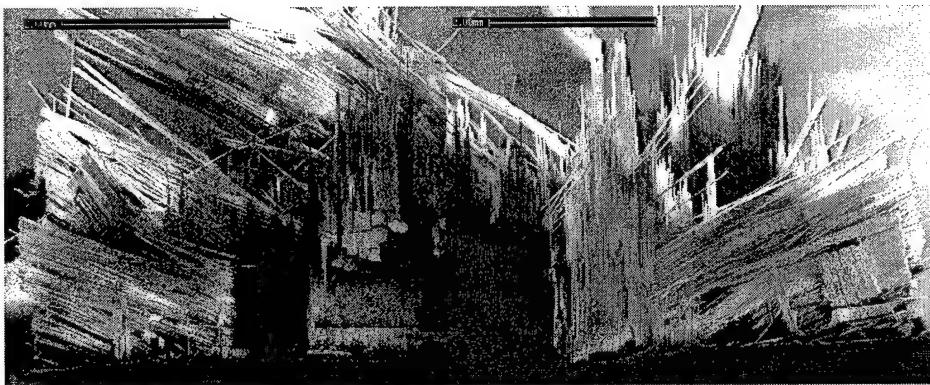
The following pictures show the fracture surface of the specimen which was fatigued for 100,000 at 70% UTS then tested for retained strength. Figure 4-28 shows the fracture surface magnified to 20X. The surface appears much like the surface shown in Figure 4-8 for the room temperature tensile tests. Subjecting the specimen to 100,000 stress cycles did not change the fracture behavior. This is a good composite failure exhibiting a very fibrous and rough texture. This figure also shows the charging phenomenon mentioned in Section 3.1.3. The tops of long fibers are especially susceptible to charging by electrons from the SEM.

Figure 4-28 Fracture surface of room temperature fatigue specimen after retained strength test, 20X

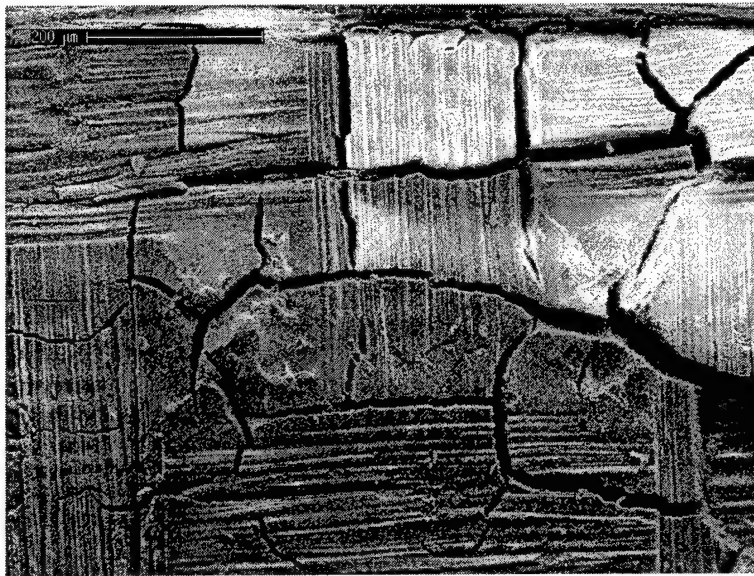
Figure 4-29 shows the cracked condition of the matrix on the specimen surface. The matrix is so cracked in the as received condition that it is impossible to tell which of these cracks if any occurred during fatigue. But the data in this section shows the composite is damaged slightly during fatigue and a likely source of this damage is cracking of the matrix beyond the original cracked condition.

Figure 4-29 Surface of room temperature fatigue specimen after retained strength test, 140X
